Ground-Penetrating-Radar Profiles of Interior Alaska Highways

Interpretation of Stratified Fill, Frost Depths, Water Table, and Thaw Settlement over
Ice-Rich Permafrost

August 2016

Final Report

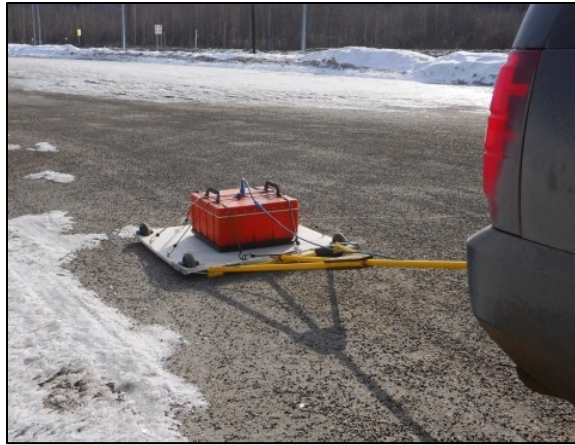
Figure 1. A GSSI Model 5106A “200 MHz” antenna unit in tow on a metal-free sled and on a high-density polyethylene ($\epsilon = 2.4$) platform. The actual center frequency of pulses received was closer to 150 MHz. The Model 5103 “400 MHz” unit is of identical design but smaller.

We used a GSSI SIR3000 16-bit control unit and the GSSI bistatic Model 5103 “400 MHz” and Model 5106A “200 MHz” antenna units. After impedance loading by pavement contact, the center frequencies were about 320 and 150 MHz, respectively. We towed the antennas very close to the surface by using the polyethylene platform shown in Figure 1. The antenna height above the surface was 5.7 cm, which added 0.6 ns (nanoseconds) to the delay of subsurface events, accounting for the 2.54 cm of high-density polyethylene.

The photograph of the antenna unit in Figure 1 was taken at the start of the profiling at the east end 100 m west of the fire station. As with the Elliott, the profile was recorded along the shoulder. We were able to record at only 150 MHz due to the length of the profile and time constraints. We used $\epsilon_r = 6$ for our depth calibration, based on conduit diffractions.

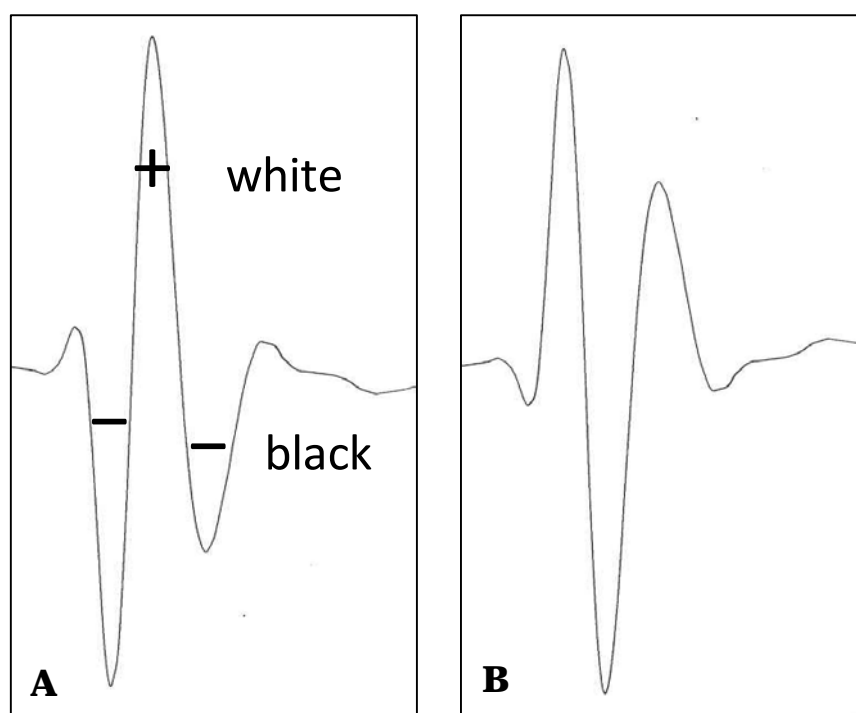
Figure 2. (A) Transmitted pulse shape and (B) its inversion after reflection from an interface between material of relatively lower permittivity above and higher below (e.g., frozen soil/unfrozen soil). The pulse does not invert if the higher permittivity material is above the interface. These are also the waveforms for thin embedded layers of relatively low permittivity (A) and relatively high (B). In the profiles, positive half cycles are white; and negative are black.

Transmitted pulse waveforms for all antennas were mainly 1.5 cycles with a $- + -$ polarity sequence for the sequential half cycles (Figure 2A). This sequence also occurs for a reflection from an interface between a relatively higher ϵ_r medium (e.g., thaw) above a relatively lower ϵ_r one (e.g., frozen) and from an isolated electrically thin (less than 0.4 wavelengths) layer with ϵ_r lower than that of the surrounding matrix, such as a thin layer of remnant seasonally frozen material above and beneath unfrozen material. The opposite cases reverse the sequence. Pulse lengths in frozen sands and gravel ($\epsilon_r = 5$) at 150 and 320 MHz are approximately 1.34 and 0.63 m,

respectively, giving a vertical interface resolution of 67 and 32 cm, respectively. The beamwidth along the antenna direction (to the side of the transects) is 53° measuring to the first null in the antenna directivity pattern. In the transect direction, the beamwidths are extremely wide (at least 70°).

The profiles provide stratigraphic sections in a line-intensity format with a nonlinear proportion between intensity and signal strength to give weaker signals greater amplification. Black bands represent negative amplitude half cycles, and white bands are positive. An isolated pulse has either black–white–black (– + –) or white–black–white (+ – +) banding.

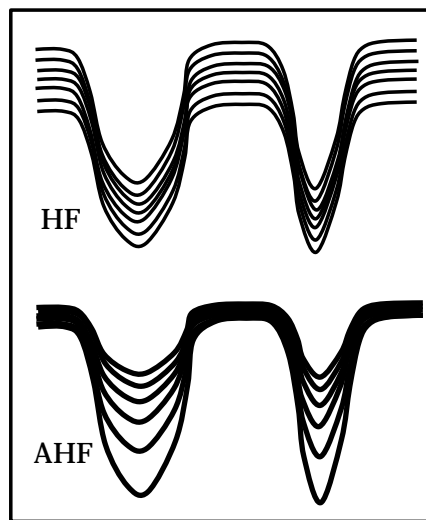
Figure 7. The key to interpretation of the presence of massive or concentrated ice. HF shows harmonic folds, in which all folds are concentric. This would occur if the folds are a reaction to only recent sagging so that the fold in the upper few layers projects down through the GPR column. AHF shows anharmonic folds, in which the folds deepen with depth, which means they are old and indicate long progressing settlement.

The most interesting features are the wavy horizons, which are pseudo-folds caused by thaw settlement over ice deep within the permafrost. The HF and AHF labels indicate either harmonic folding or anharmonic folding, as explained in Figure 7. Harmonic folds (HF) are concentric, which occurs if the folds are a reaction to only recent sagging so that the fold in the upper few layers projects down through the GPR column (i.e., the fold

at the top affects deeper strata). Layer slippage during compression also causes this. The deeper folding is then just a velocity “pull-down” from recent surficial sagging. Anharmonic folds (AHF) deepen with depth, which means they are old and indicate a long history of settlement. With each episode of road repair, the layers continually deepen and fold. The labels in Figure 5 are below the appropriate folding features.

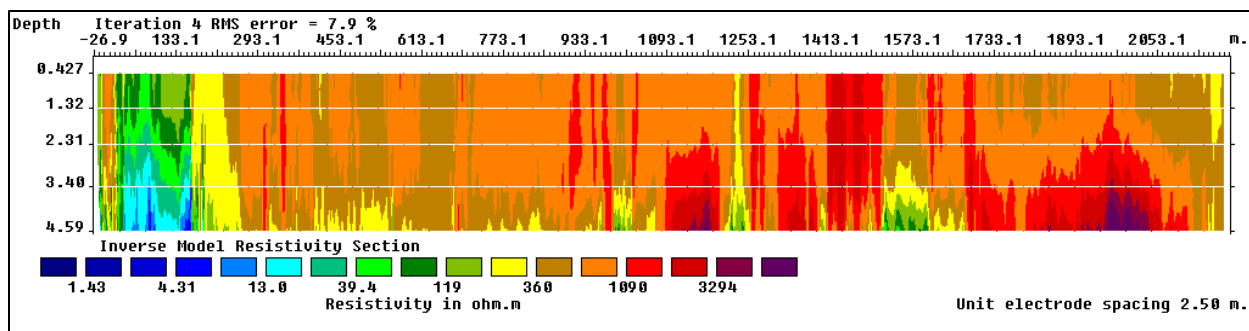
Figure 8. The OhmMapper resistivity profile (2.5 m electrode spacing) along the Elliott Highway. *Red to dark red* indicates high ice content. The maximum profile depth is 4.6 m, similar to the profile horizons. The highest resistivity is at 1000–1220 m (deepest gravel fill), 1250–1500 m (thaw settlement under folding), and 1700–1800 m where no horizons greater than 1 m suggest high attenuation (e.g., *barely* frozen, such as ice-rich silt, or thaw). A borehole at 1752 shows frost to 4.3 m, wet silt to 5.9 m, then frozen silt, which is consistent with this figure because it shows high resistivity to a 4.6 m depth.

Figure 8 shows the OhmMapper capacitive-coupled electrical-resistivity profiles. Consistently, the highest resistivity is at the 1000–1220 m distance, where the deepest gravel fill occurs; at 1250–1500 m, where thaw settlement is indicated by folding; and at 1700–1800 m, where no horizons greater than 1 m suggest high attenuation (e.g., *barely* frozen, such as ice-rich silt, or thaw). At this location, the borehole log at 1752 shows frost to 4.3 m, wet silt to 5.9 m, and then frozen silt.

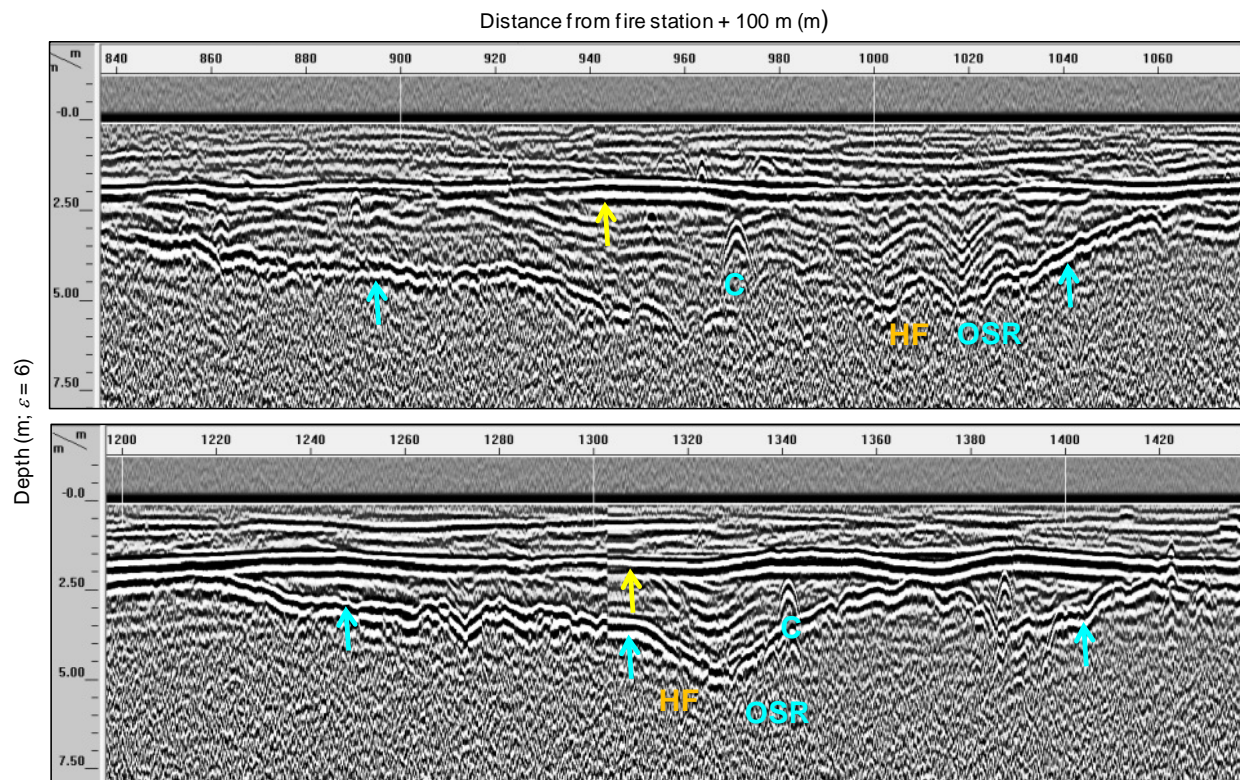
Figure 11. 150 MHz profile sections between 840 and 1440 m along Goldstream Road, recorded 9 April 2014. *Yellow arrows* indicate the frost depth, and *turquoise arrows* indicate the water table. Folds indicate thaw settlement. Old thaw settlement repair (OSR) occurs where folds do not continue to the surface. Conduits (C) are indicated by hyperbolic diffractions.

Figures 11–15 show the most interesting sections and include a feature not seen along the Elliott: a buried remediation surface from repair of old thaw settlement. Both sections in Figure 11 show two prominent horizons, the phases of which indicate the frost depth and water table. The frost depth is at about 1.5 m, which is about 1 m less than along the Elliott. Folding occurs directly below this horizon in both profile panels and so occurs in older sand and gravel fill. Because there is no folding above it, this thaw settlement has been remediated; and there is currently no indication of continued settlement. Consequently, it appears that the frost depth has reached only the depth of the new sand and gravel fill. When the remediation occurred is not known. The folds appear harmonic, which means all

settlement happened concurrently. Close examination of the lower panel near 1320 m shows that the remediated section was initially planed, thus presenting an artificial erosional unconformity.

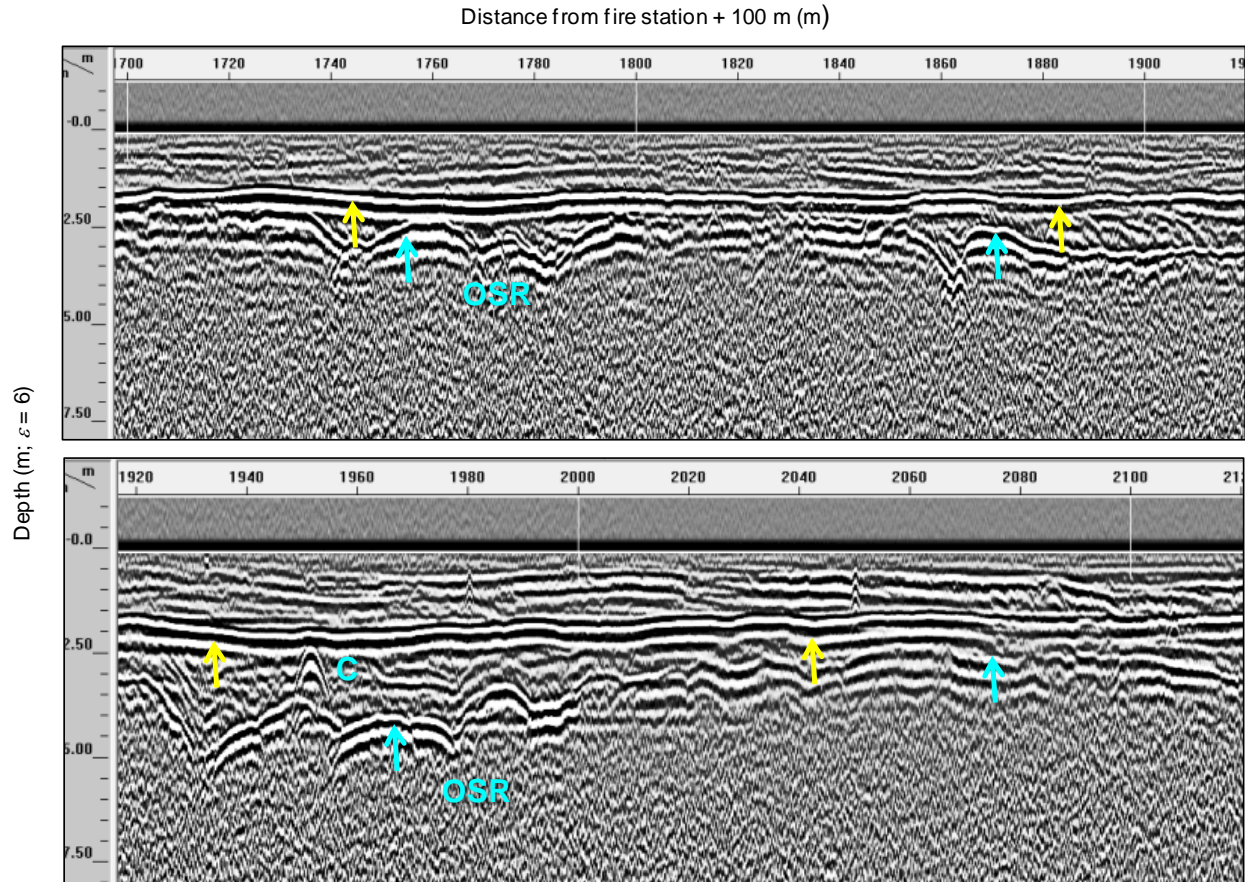
Figure 12. A 150 MHz profile section between 1700 and 2120 m along Goldstream Road, recorded 9 April 2014. *Yellow arrows* indicate the frost depth, and *turquoise arrows* indicate the water table. Folds indicate thaw settlement. Old thaw settlement repair (OSR) occurs where folds do not continue to the surface. Conduits (C) are indicated by hyperbolas.

Figure 12 shows two profile panels that exhibit the same phenomenon of remediated settlement. Above the frost depth, there is no folding, while harmonic folds appear below it. As in Figure 11, the water table exceeds 5 m in depth in one spot.

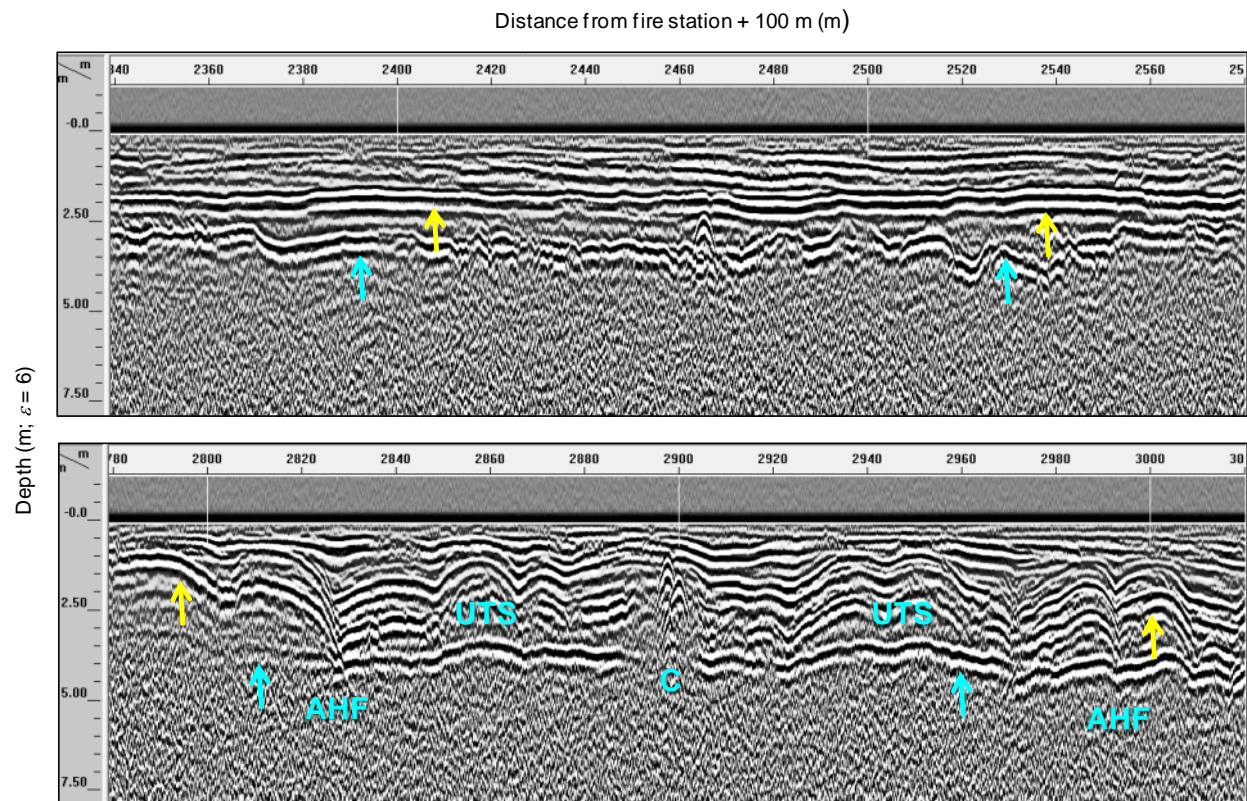
Figure 13. Selected 150 MHz profile sections between 2340 and 3020 m along Goldstream Road, recorded 9 April 2014. *Yellow arrows* indicate the frost depth, and *turquoise arrows* indicate the water table. Folds indicate thaw settlement. Old thaw settlement repair (OSR) occurs where folds do not continue to the surface. Unrepaired thaw settlement (UTS) is indicated by folds that continue to the surface. Conduits (C) or clusters of conduits are indicated by hyperbolas.

Figure 13 presents two panels with different situations. In the upper panel, the frost depth and water table horizons are evident; but there is little evidence of any thaw settlement. The lower panel, however, shows unrepaired thaw settlement (label UTS) folding that begins near the surface and continues down to the water table. The fold limbs increase with depth, which is an example of anharmonic folding (Figure 7). At 2900 m, there is a cluster of diffractions, which indicates several conduits. Near these diffractions, the water table horizon is not visible. We surmise that this is because of better heat conduction by the conduits.

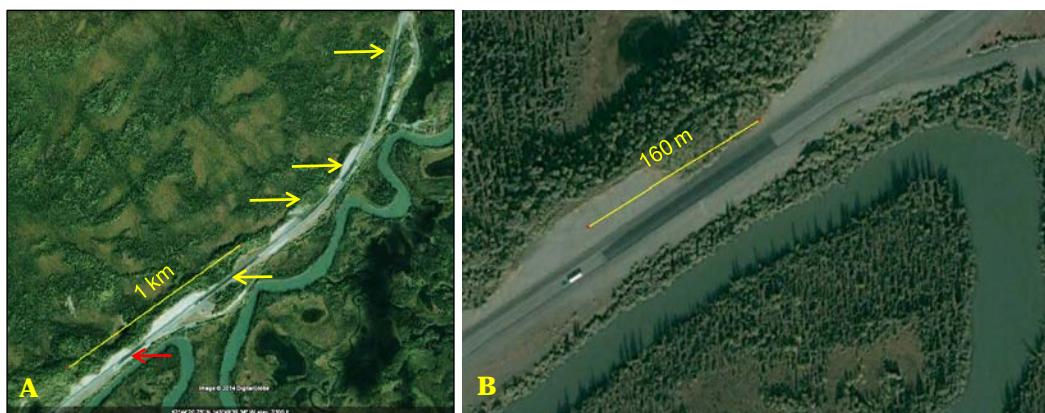
Figure 16. (A) An image from 9 April 2013 of the section of Tok Highway that has been repeatedly repaired since at least 1997. Arrows indicate black patches where thaw settlement has been repaired. (B) Detail of the area (indicated by red arrow in A) discussed in this report.

is about 75.6 km to the south. Consequently, limited stratification should be expected. The nearest present glacier is about 43.4 km away. When the cut was made (estimated 1990–1997), the road crew encountered blue ice that appeared to be of glacial origin. An unknown thickness of insulating layer of Styrofoam was placed on the ice, and the cut was refilled to a 5 m thickness. At the time we surveyed, the road was uneven with obvious thaw settlement. Today (Figure 16), there are numerous patches in this area, showing that the thaw settlement has continued.

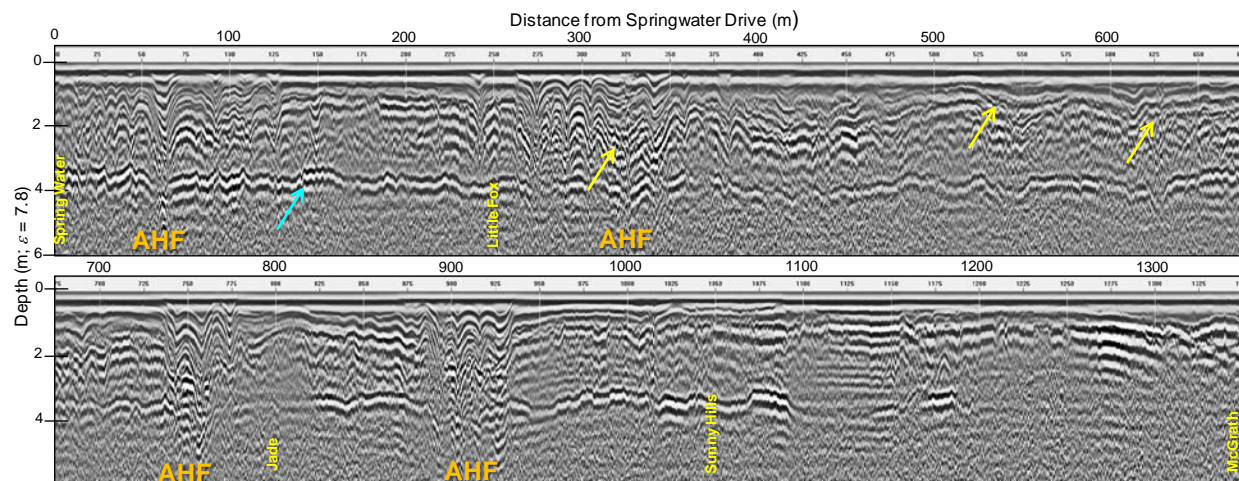
Figure 19. A 150 MHz profile of a section of the Old Steese Highway going N-S and recorded 9 August 2013.

The black-white-black horizon (*turquoise arrow*) means thaw over frozen. The $\epsilon_r = 7.8$ is the average for several conduit diffractions (*yellow arrows* at 325, 545, and 628 m), which are not discernible because of the horizontal compression used for display, and indicates well-drained sands and gravel. Diffractions generated within the nadir of a dip were not considered for interpretation of relative dielectric permittivity.

settlement. Only Little Fox Road lies within one of these sections; the other roads do not. The folding is severe and anharmonic, meaning that the settlement has progressed for many years. The medium below is also not likely to be seasonal frost or else a second reflection from either a water table or from permafrost would appear.
